## **The Painted Room, 9 Market Street, Whittlesey**

*Condition and significance assessment: 9th - 13th July 2018*

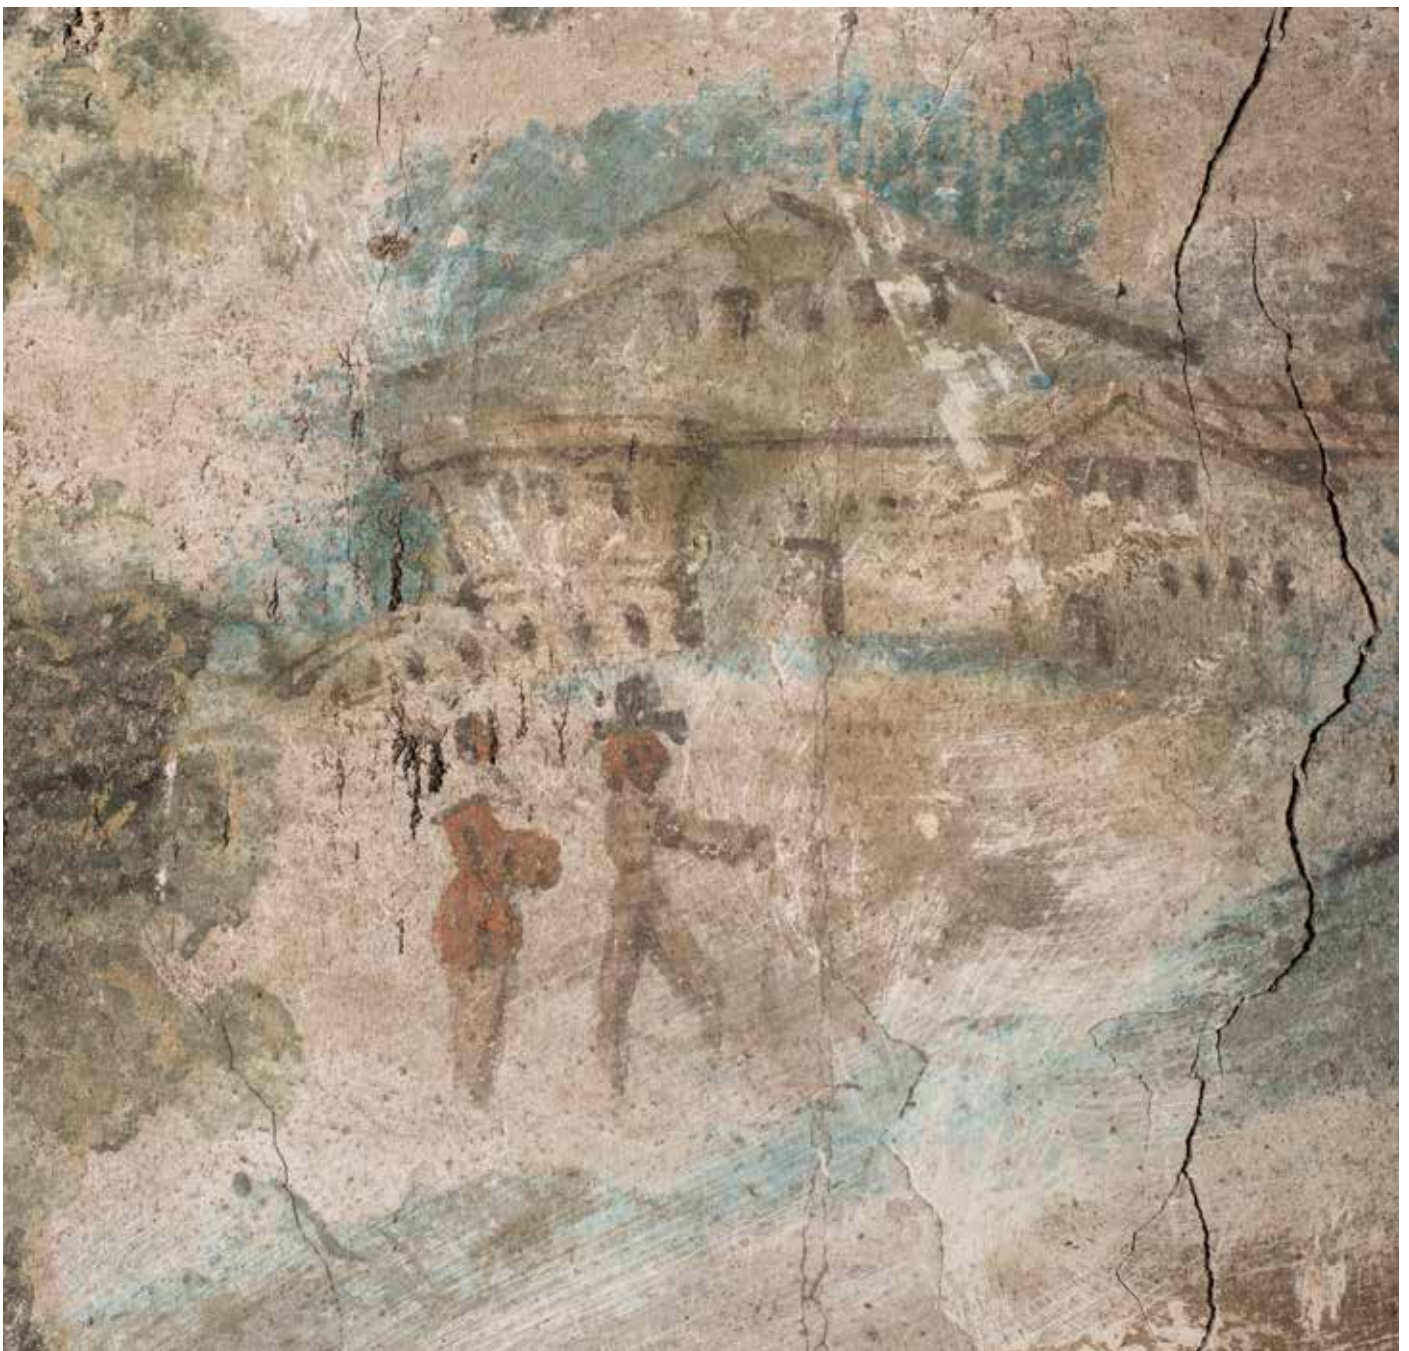
## Table of Contents

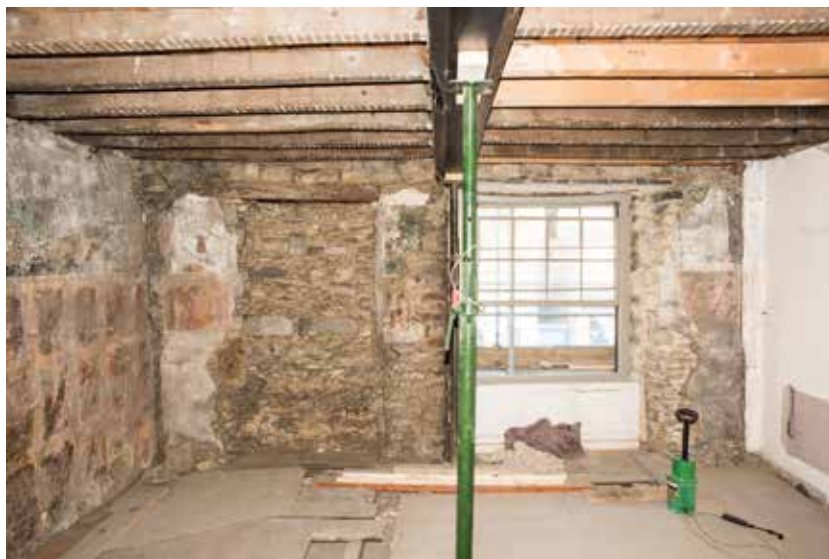
Figs. 3. General view looking north of the painted room as found. Painting survives on the north and east walls.

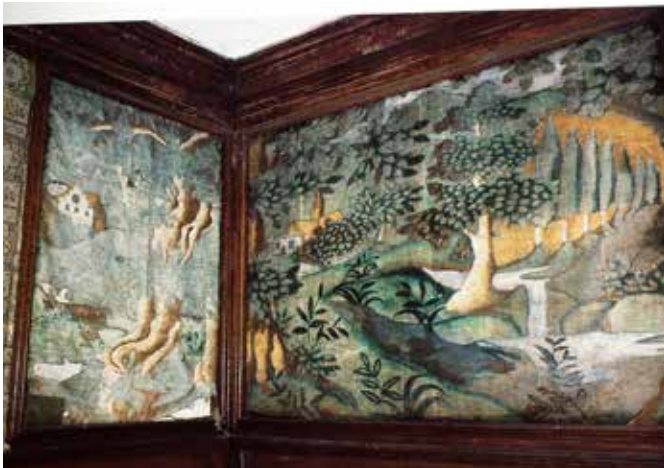
Fig. 4a The stained hangings of Munslow Farm, Shropshire. Dating from around 1700.

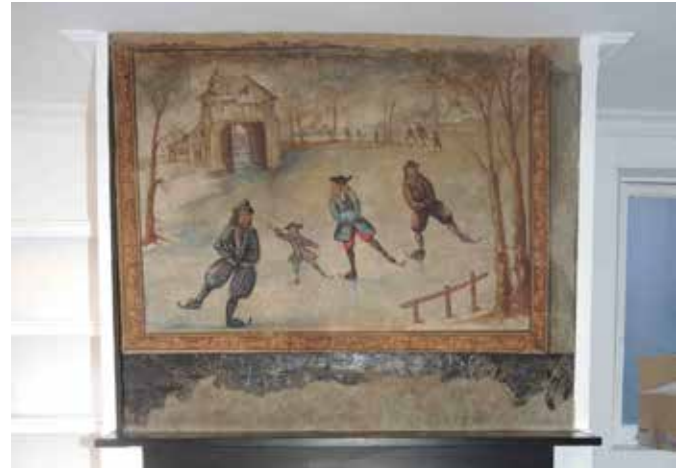
Fig. 4b Paintings from 2 Wardrobe Place, with a similar fictive boarder and landscape scene with figures.

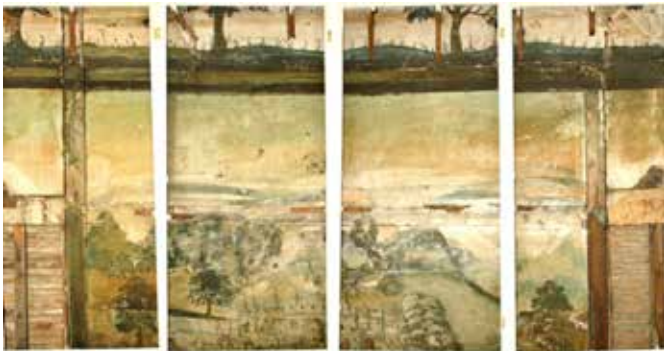
Fig. 4c Paintings from Lincoln College dating to approximately 1630. A similar landscape and palette is found at Whittlesey.

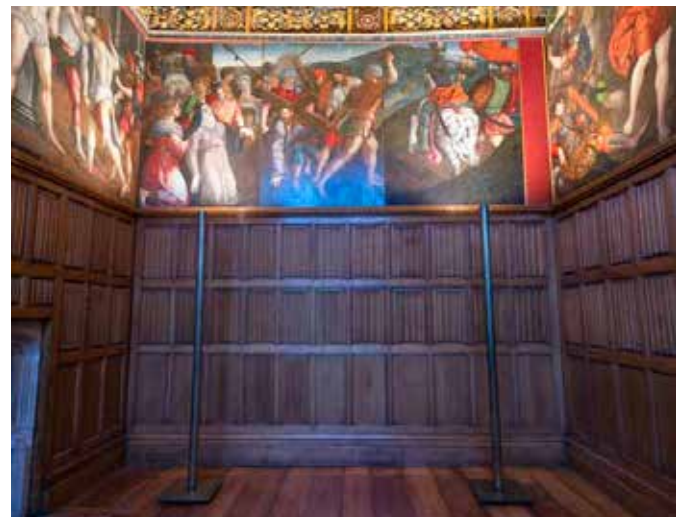
Fig. 5 General view of the Wolsey Closet at Hampton Court Palace showing three-quarter height wooden panelling, above which are landscape format panel paintings. The same compositional elements are found at Whittlesey.

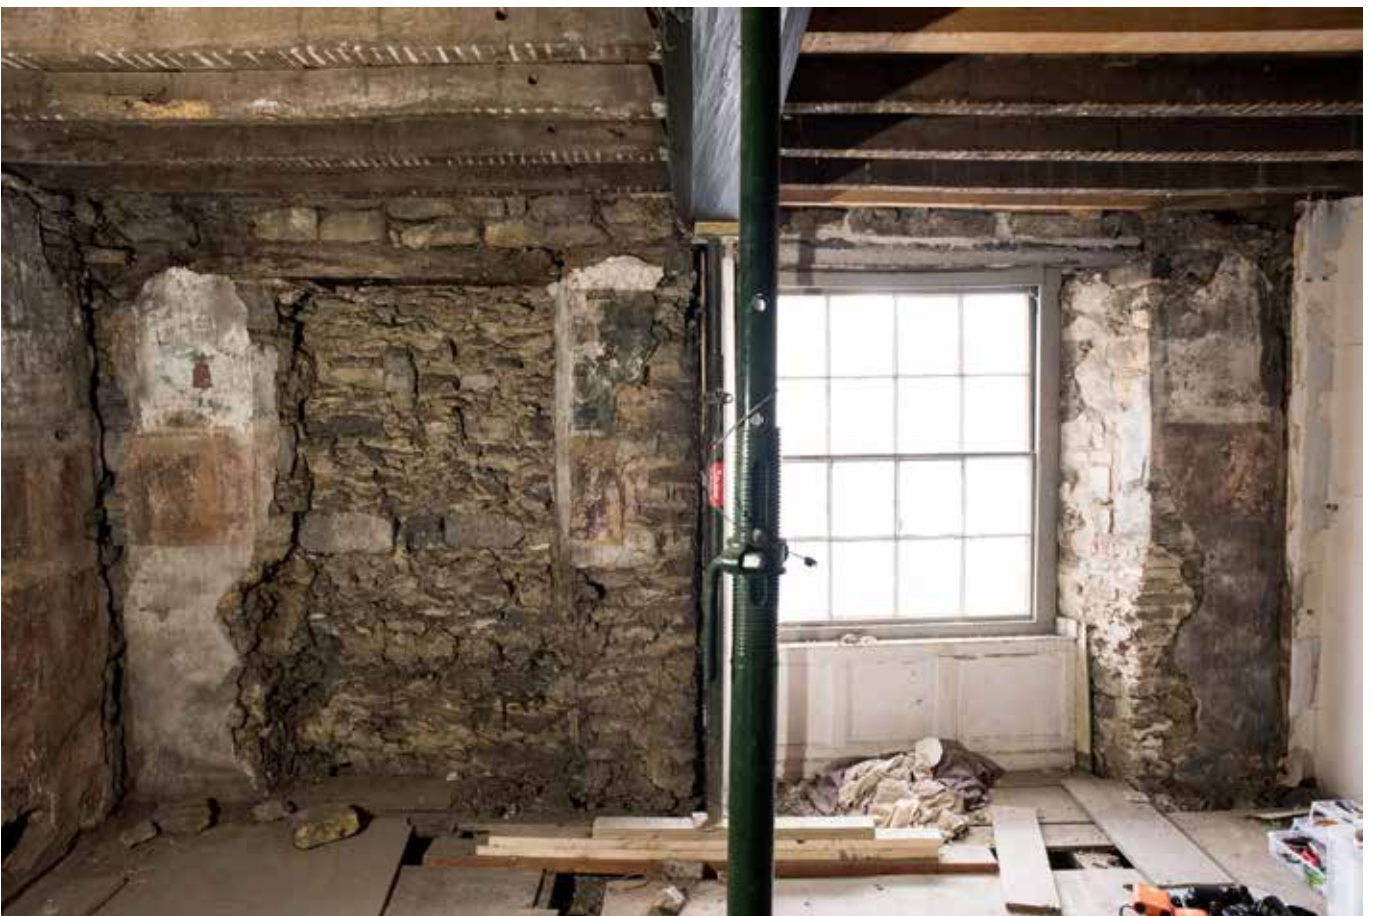
*Figs. 7-8. General view of the north wall of painted room. Three fragments survive. Two of which show figures in seventeenth century dress. The third panel (to the far right of the image) is badly deteriorated and no detail can be discerned.*

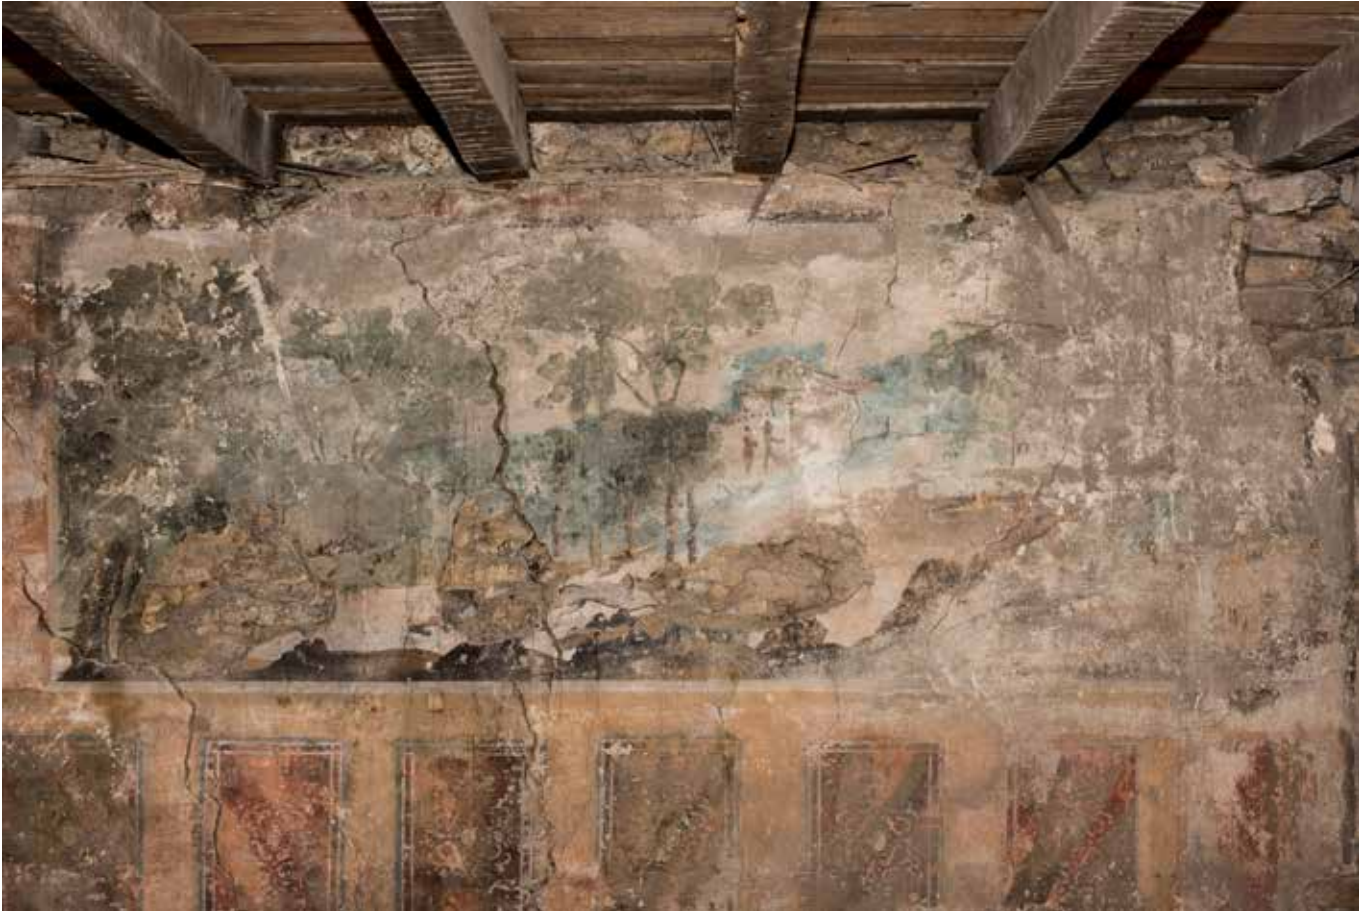
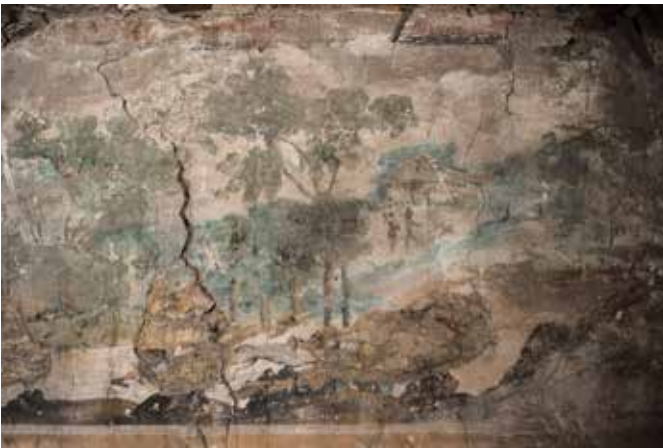
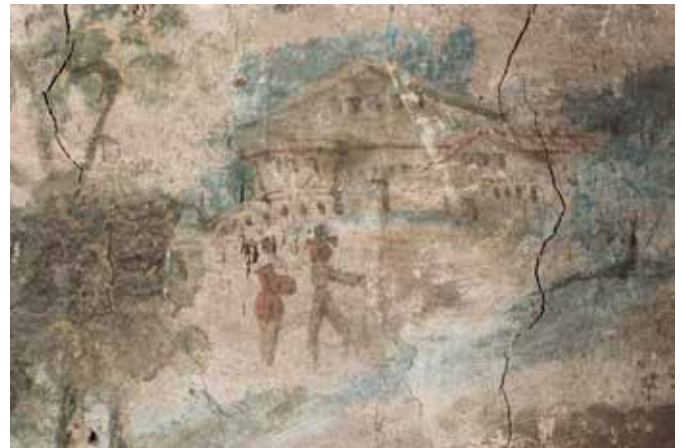
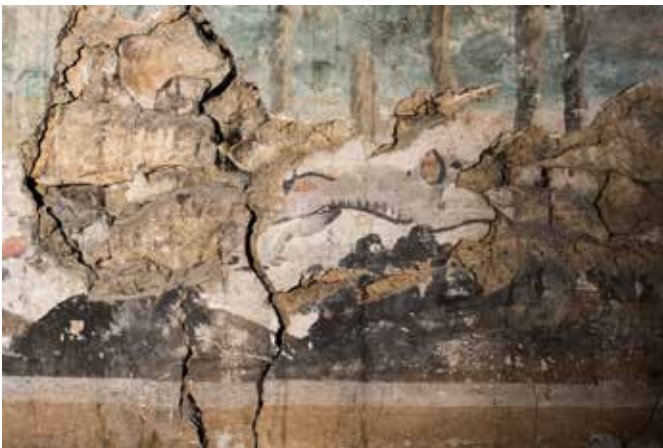
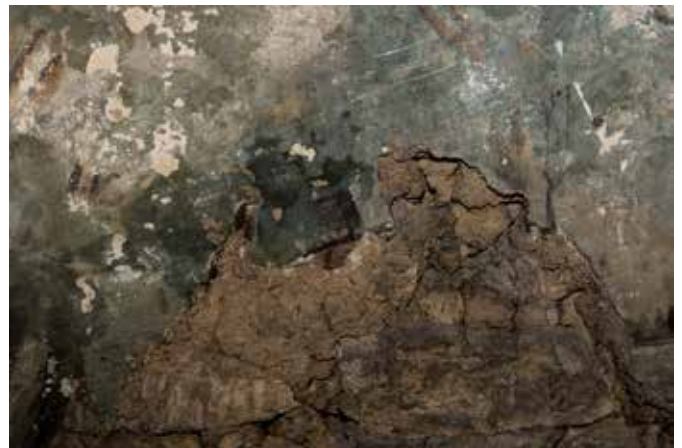
*Figs. 9-13. Detail views of the right landscape scene on the west wall. The middle left and right images show two figures outside what appear to be classically influenced buildings. The lower left images show the remains of a dog and the leg of a man. The lower right, the traces of a mans hat.*

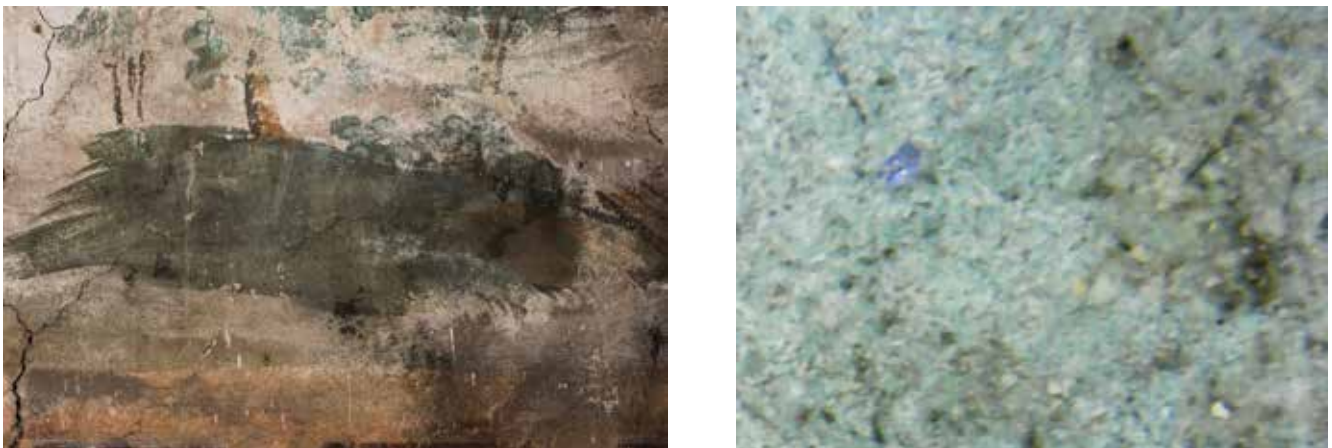
*Figs. 31-32. The greens appear to have been created by mixing blue with a possible organic colorant.*

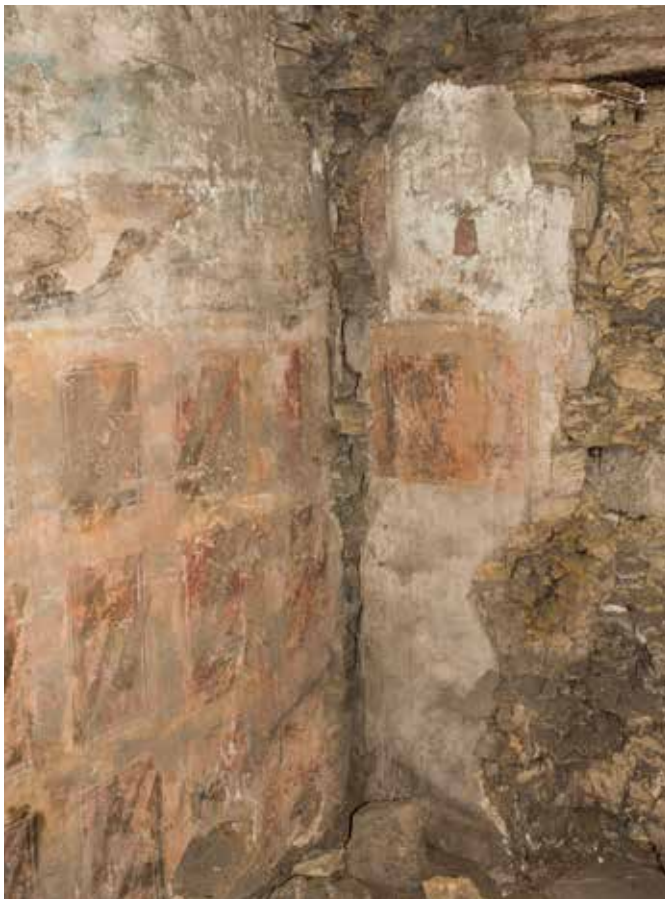
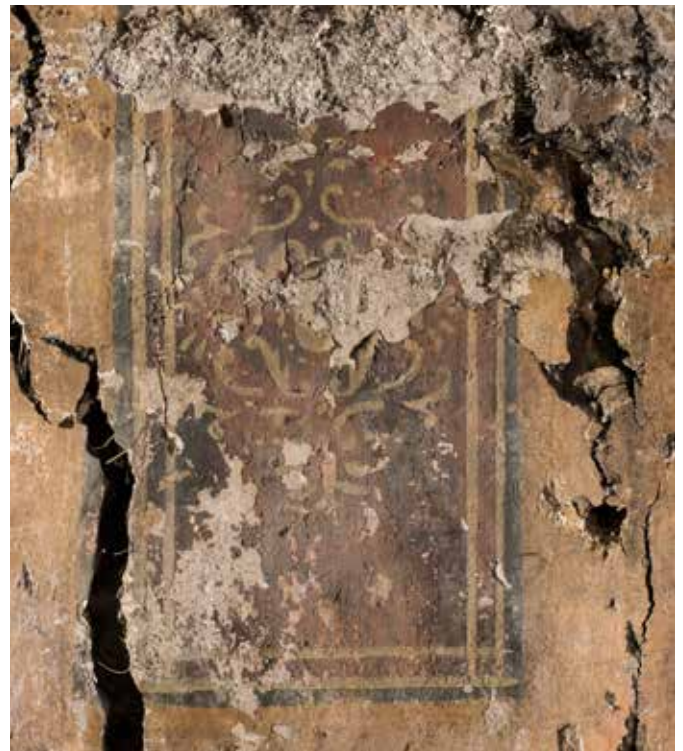
*Figs. 33-34. Cracking and fracturing has caused severe damage and loss to the paintings. The cracking is either caused by loading on the walls or structural movement.*

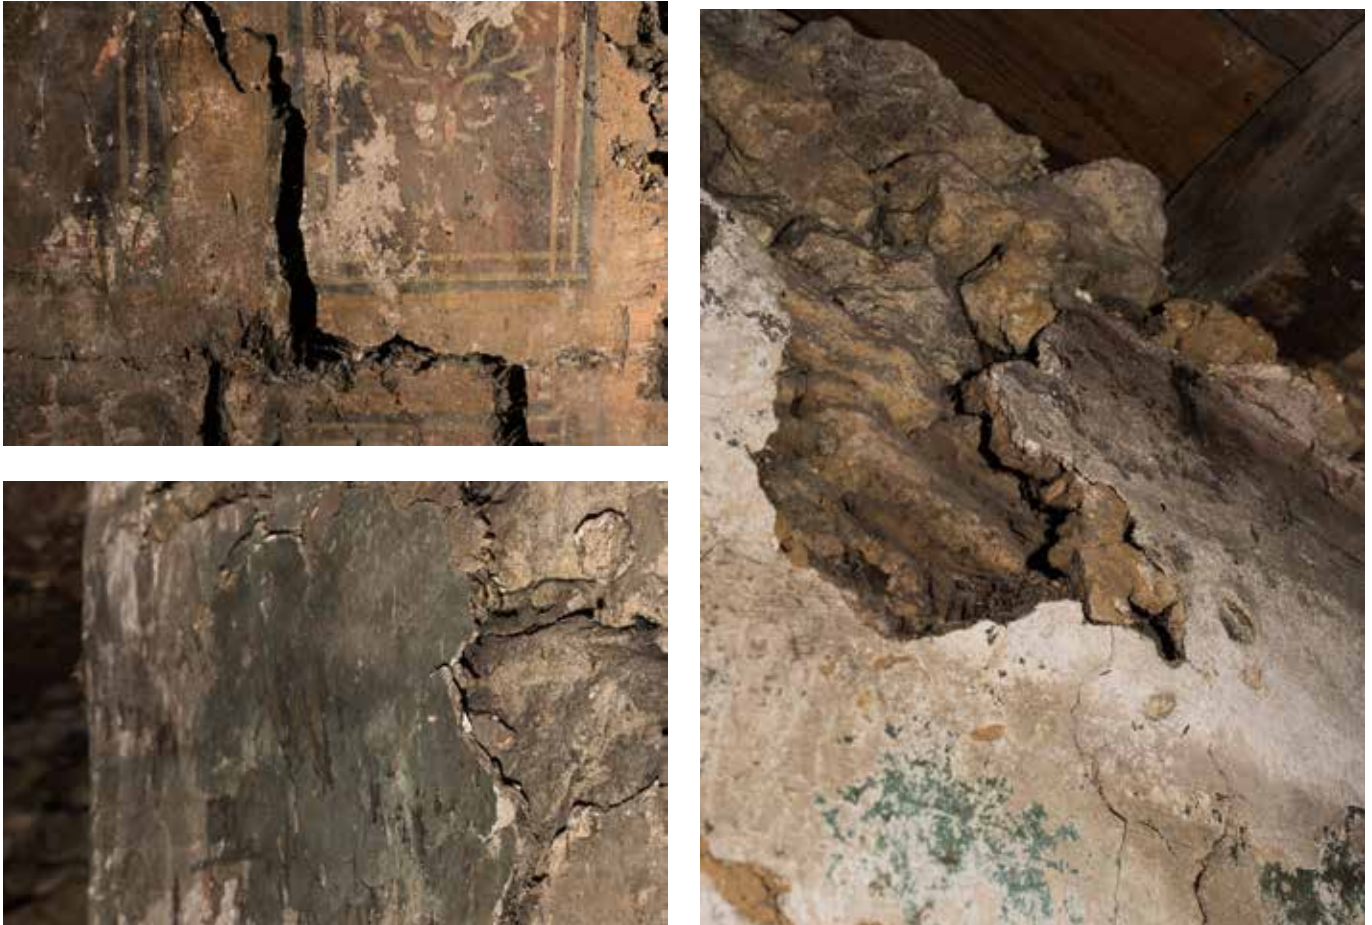
*Figs. 35-37. Examples of where de-lamination is occurring. The plaster has separated from the layer beneath leaving a void beneath.*

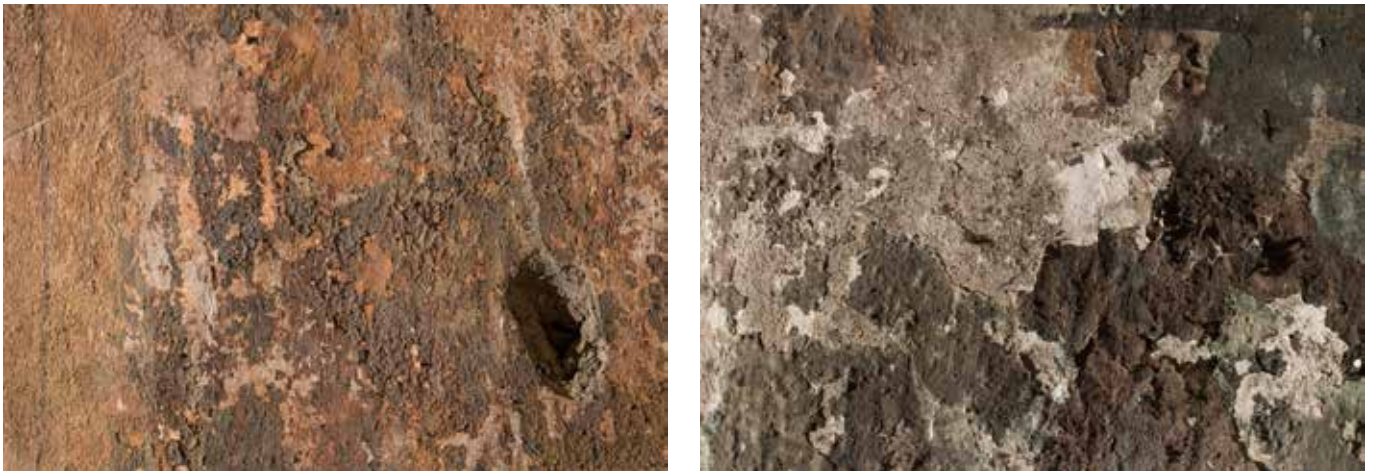
*Figs. 39-40. Left, an area where flaking and powdering are causing paint loss. Right, flaking is ongoing on the north wall where the couple are depicted holding hands.*

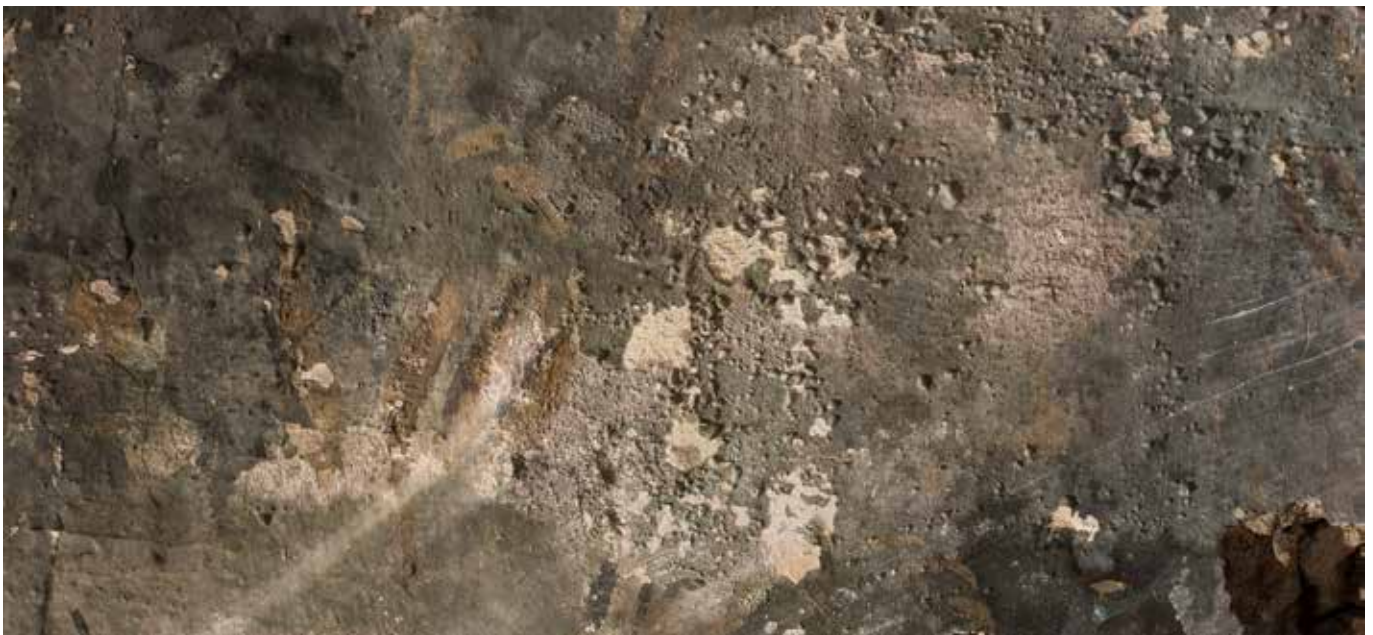
*Figs. 41-42. The paint layer appears to have blistered in localised areas. This may be a result of moisture ingress.*

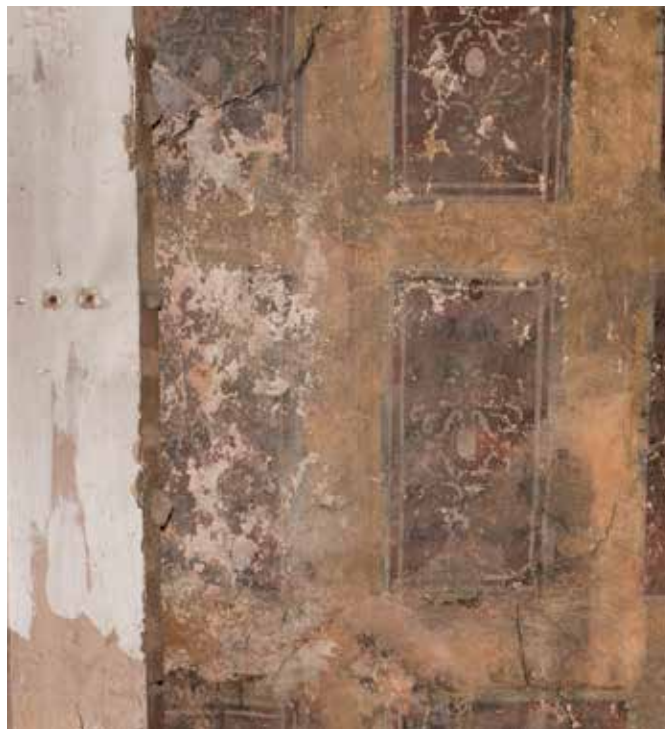
*Fig. 43. The presence of a boiler in front of the paintings may have caused the flaking, powdering and paint loss in this area. The area also has a white haze over it.*

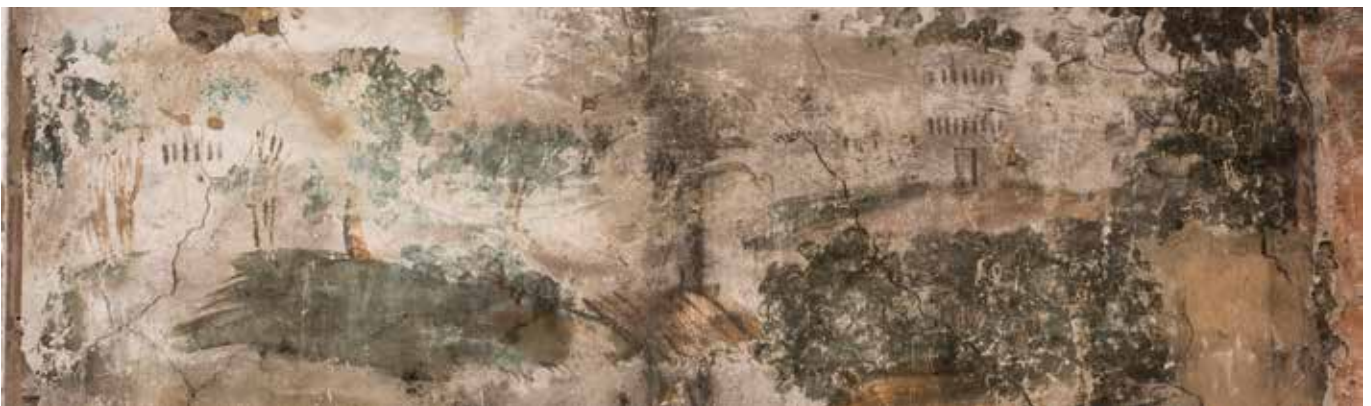
*Fig. 44. Paint loss is widespread and can be attributed to a number of different damage and deterioration mechanisms.*

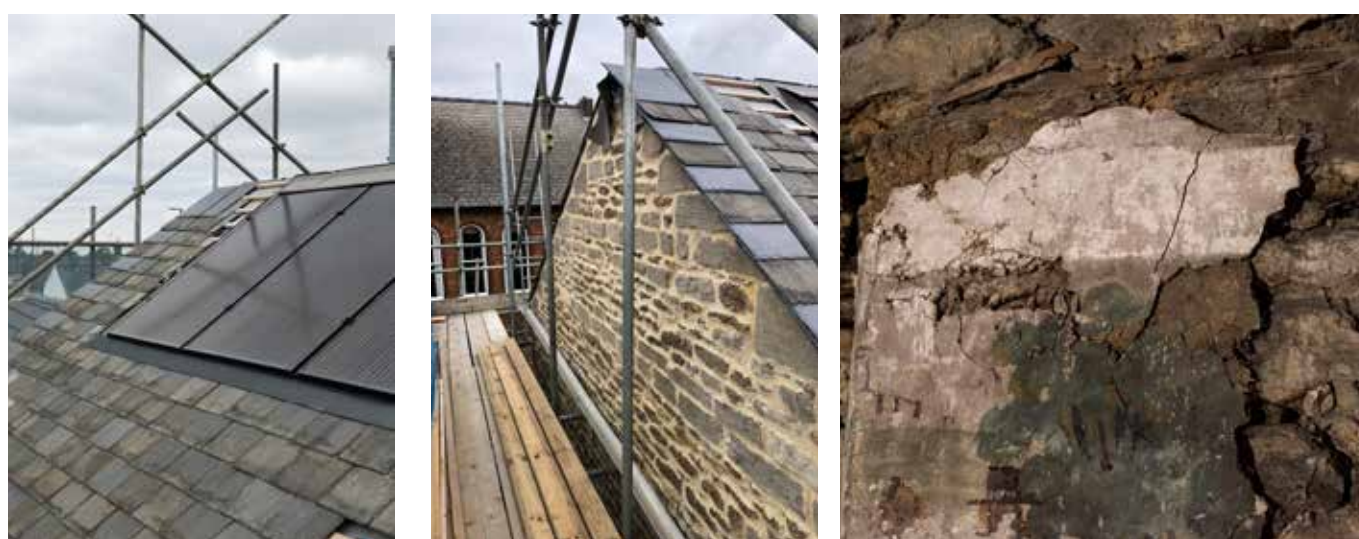
*Figs. 47-49. Left, the roof is partially open, the paintings are directly below the opening, a serious cause for concern due to water infiltration. Middle, Guttering also runs along the west wall directly above the painting. Failures to the guttering may cause serious damage to the painting is unmaintained. Right, the rotten lintel behind the painting on the north wall, plans to remove and replace the lintel threaten the survival of the painting.*

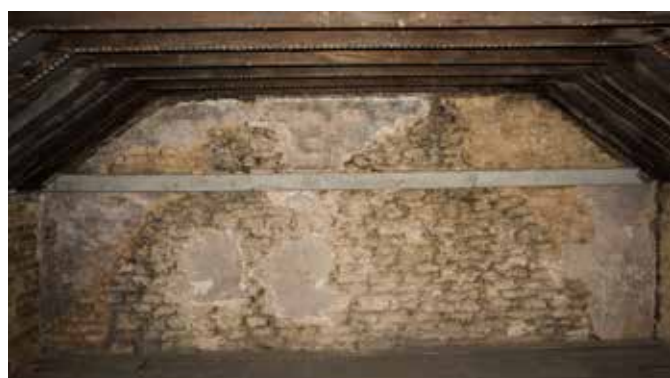
*Fig. 50. The roof space directly above the painting. The space will be used as another guest bedroom.*

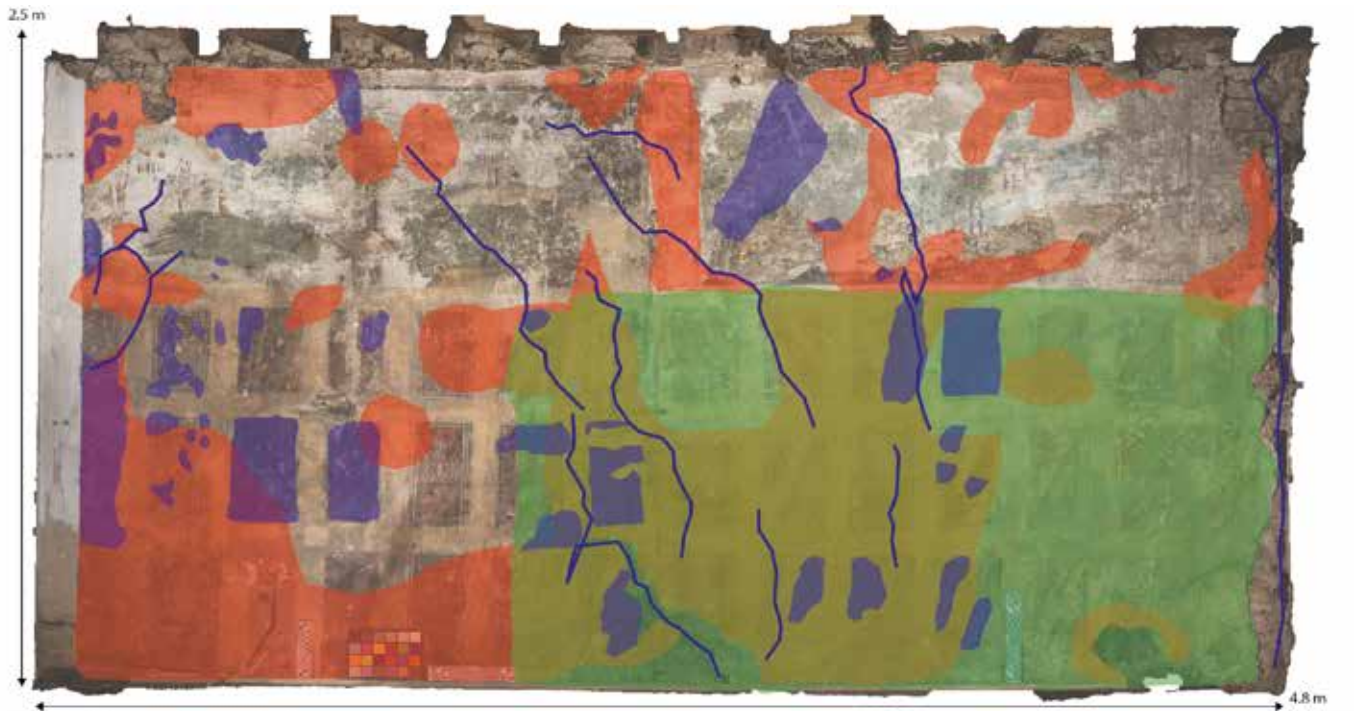
**Condition mapping**

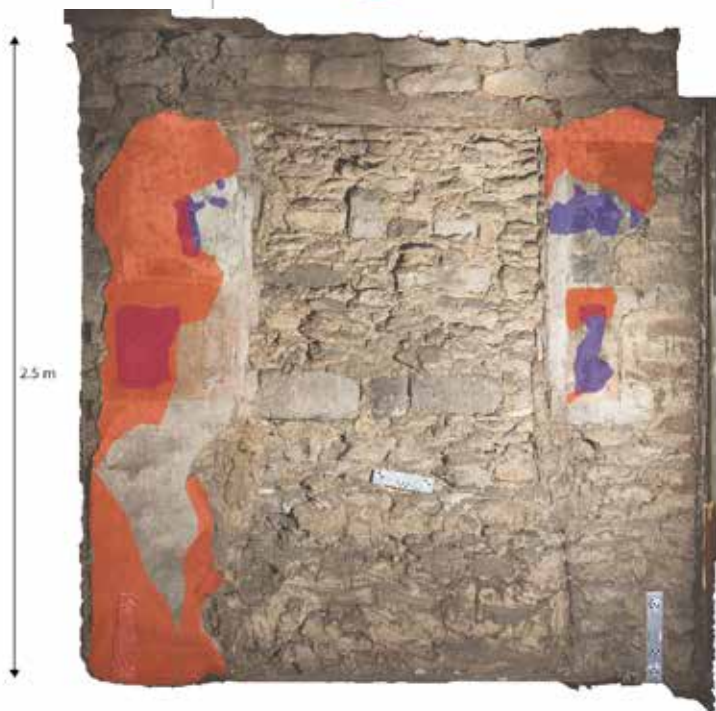
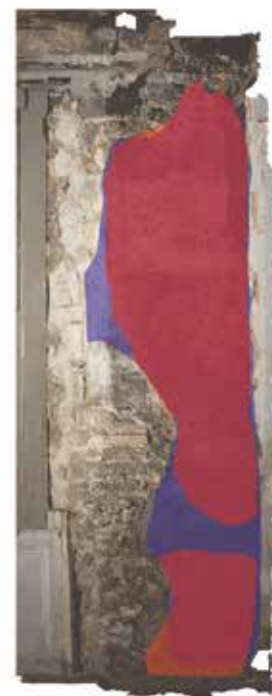
**Condition mapping**
